KIRBY INLAND MARINE

**CARGO
PIPING FLOW DIAGRAM**

SCALE: NONE	MMI 3034
PAGE: 1 OF 3	REV. 1

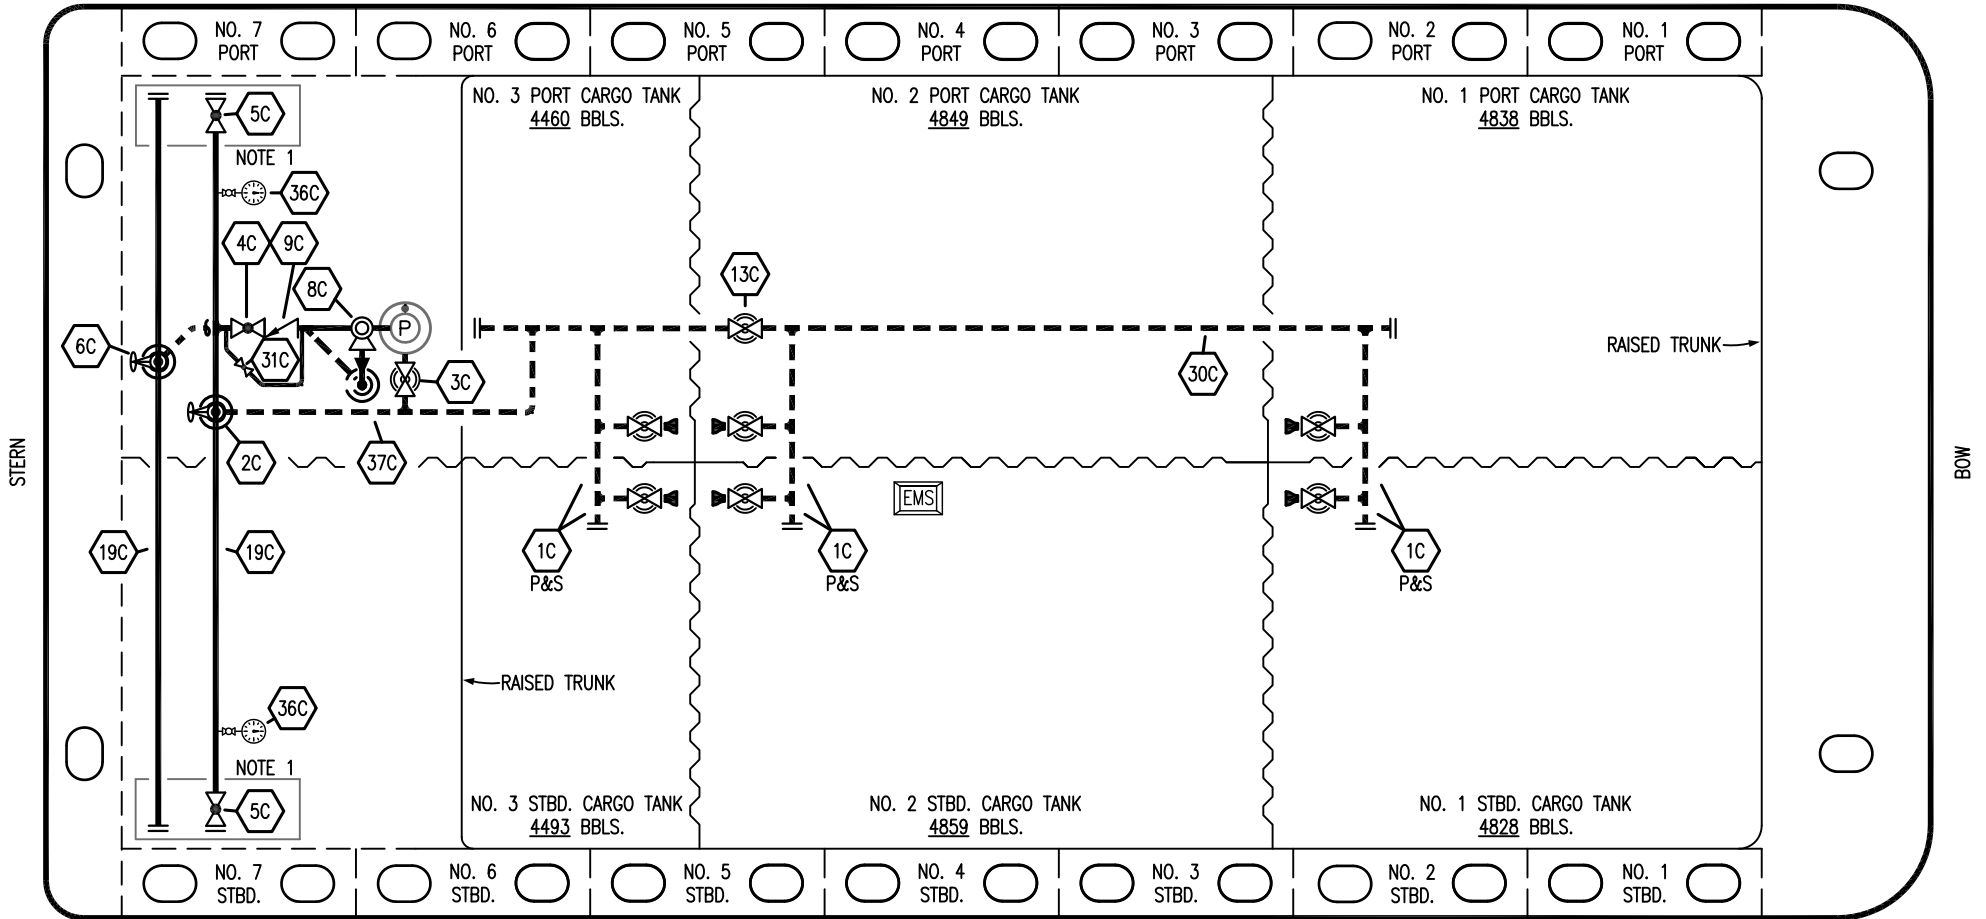
NOTE 1: CONTAINMENT P/S

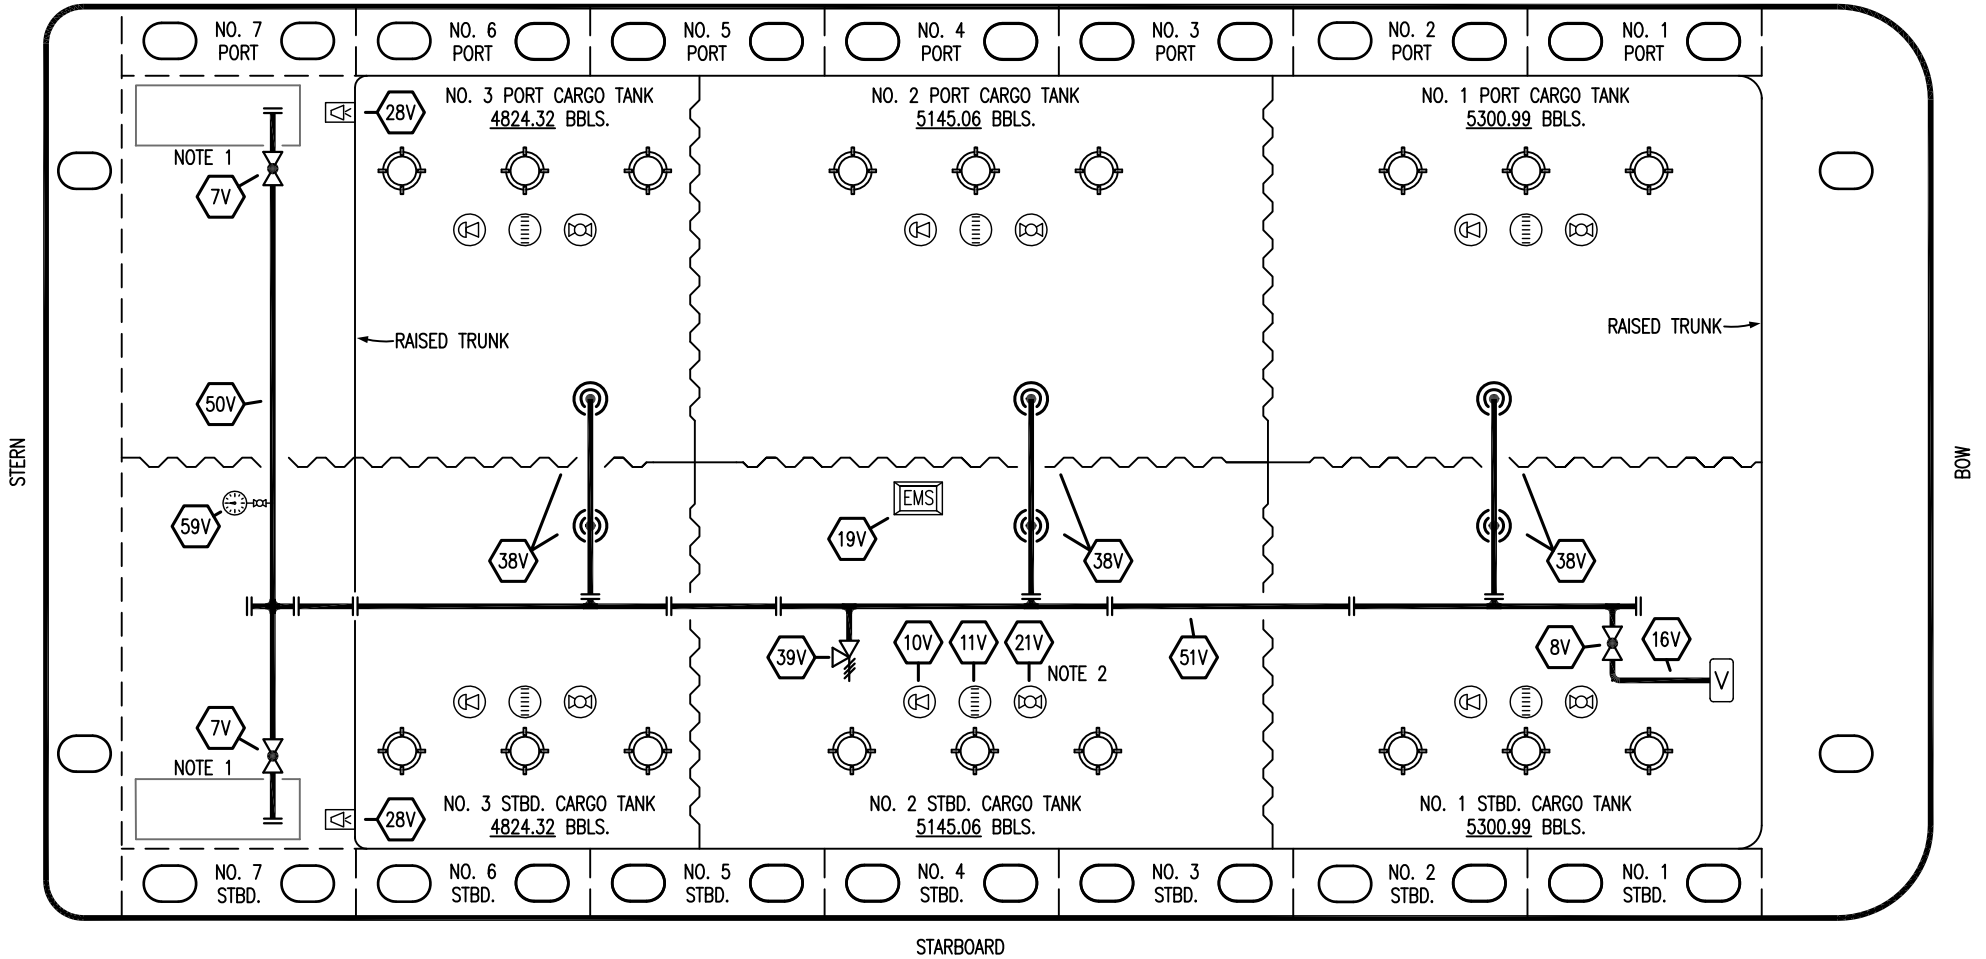
**VAPOR
PIPING FLOW DIAGRAM**

NOTE 2: TYPICAL RIGGING IN EACH TANK

NOTE 1: CONTAINMENT P/S

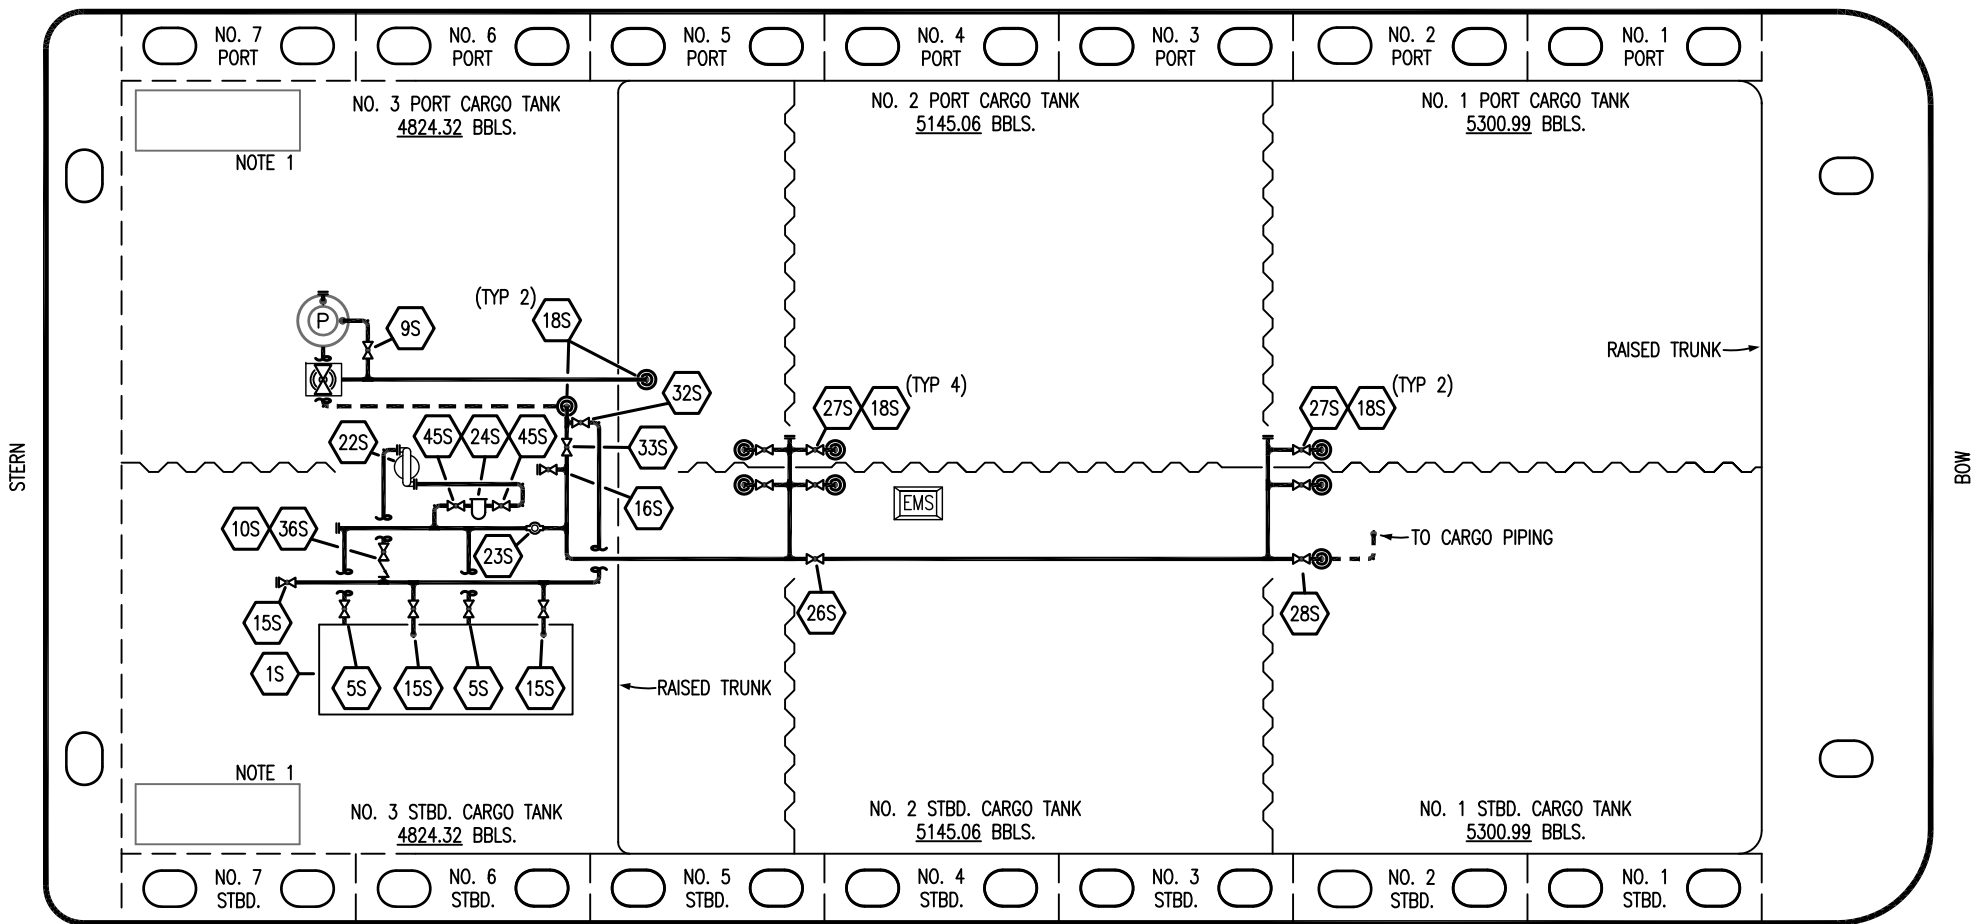
**STRIPPING
PIPING FLOW DIAGRAM**

NOTE 1: CONTAINMENT P/S
